# DECONTAMINATION OF A LARGE VACUUM DISTILLATION UNIT

ZymeFlow returned for the eighth time to a refinery in Greece to decontaminate several units during the turnaround. The equipment ZymeFlow was preparing for entry included; crude unit, two vacuum distillation units, visbreaker, and Tertiary Amyl Methyl Ether (TAME) unit. The first Vacuum Distillation Unit (VDU) was the largest vessel in the project at 31 feet (9.5 meters) in diameter. ZymeFlow Decon's objective was to eliminate contaminants within the unit and minimize the risk of pyrophoric iron sulfide.

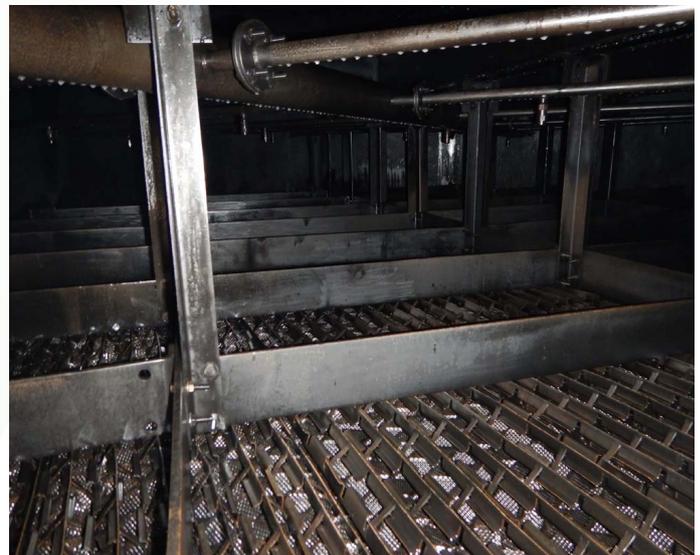
◆ VDU PACKED BED SECTIONS CONTAINED NO SCALE OR PYROPHORICS AFTER ZYMEFLOW'S PROCESS

At the end of the decontamination process the contaminant levels had reached zero inside the vessel. Upon entry, there were no pyrophoric issues and tower bottoms were completely de-oiled. The refinery was very pleased with ZymeFlow's work. The vessel was not only safe for entry in a shortened time-frame, but was also much cleaner than the refinery personnel had anticipated, with no residual sludge or scale. A refinery engineer commented that it was the best decontamination job they had ever seen done on their system. Shortened time-frame, but was also much cleaner than the refinery personnel had anticipated, with no residual sludge or scale. A refinery engineer commented that it was the best decontamination job they had ever seen done on their system.
